# SCRATCHING / CORROSION

## SIKKENS CC3000 SCRATCHER

For cutting the panel prior to the corrosion test.

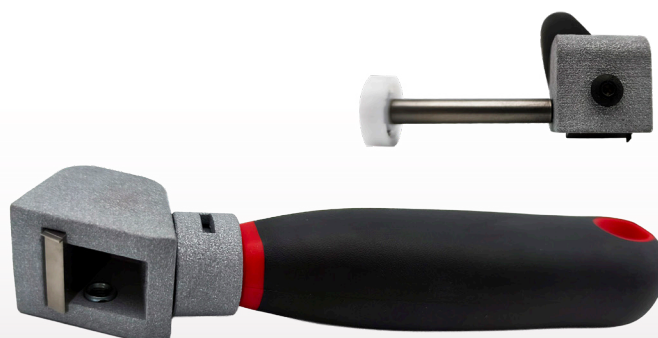
The NK Sikkens CC3000 Scratcher is a precision cutting tool designed to make incisions in coated panels or test specimens, in accordance with the requirements of salt spray chamber corrosion testing. Its tilting head design and ergonomic handle allow for uniform cuts down to the substrate with minimal effort and high repeatability, ensuring that the cut reaches the metal substrate without damaging it.

- Tilting head that compensates for hand movement, ensuring a uniform cut at a constant depth.
- Integrated blade support that facilitates positioning and guiding the cut across the panel.
- Ergonomic, low-effort handle that reduces operator fatigue during repetitive testing.
- Three interchangeable blades: 0.5 mm (Daimler Chrysler), 1 mm (original Sikkens) and 2 mm (ISO 12944-6:2018).
- Replacement blades available individually to extend the service life of the equipment.
- Complies with ISO 17872 (marking procedure for coatings for corrosion testing).

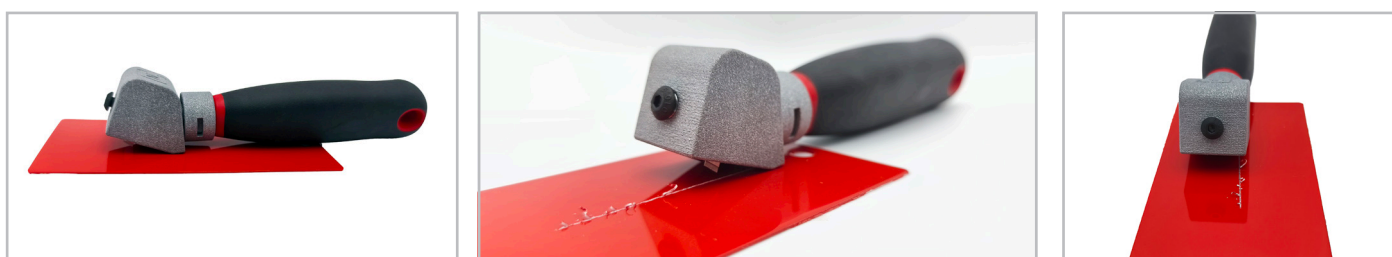
Prior to the salt spray corrosion test, a straight incision is made in the coated panel using the NK-CC3000 scoring tool. The cut must be clean, continuous and reach the metal substrate along its entire length. Following exposure to salt spray, the extent of corrosion and delamination of the coating from the edge of the cut is assessed in accordance with the applicable standard.

If the cut does not reach the substrate, the test results are invalid. In this case, the blade must be inspected and replaced if it shows signs of wear.
